**TRANSPORTATION SCIENCES
CRASH DATA RESEARCH CENTER**

Veridian Engineering
Calspan Operations
Buffalo, New York 14225

**CALSPAN ON-SITE AIR BAG RELATED CHILD FATALITY INVESTIGATION
CALSPAN CASE NO. CA96-010
VEHICLE - 1996 DODGE CARAVAN SE
LOCATION - TENNESSEE
CRASH DATE - 1996**

Contract No. DTNH22-94-07058

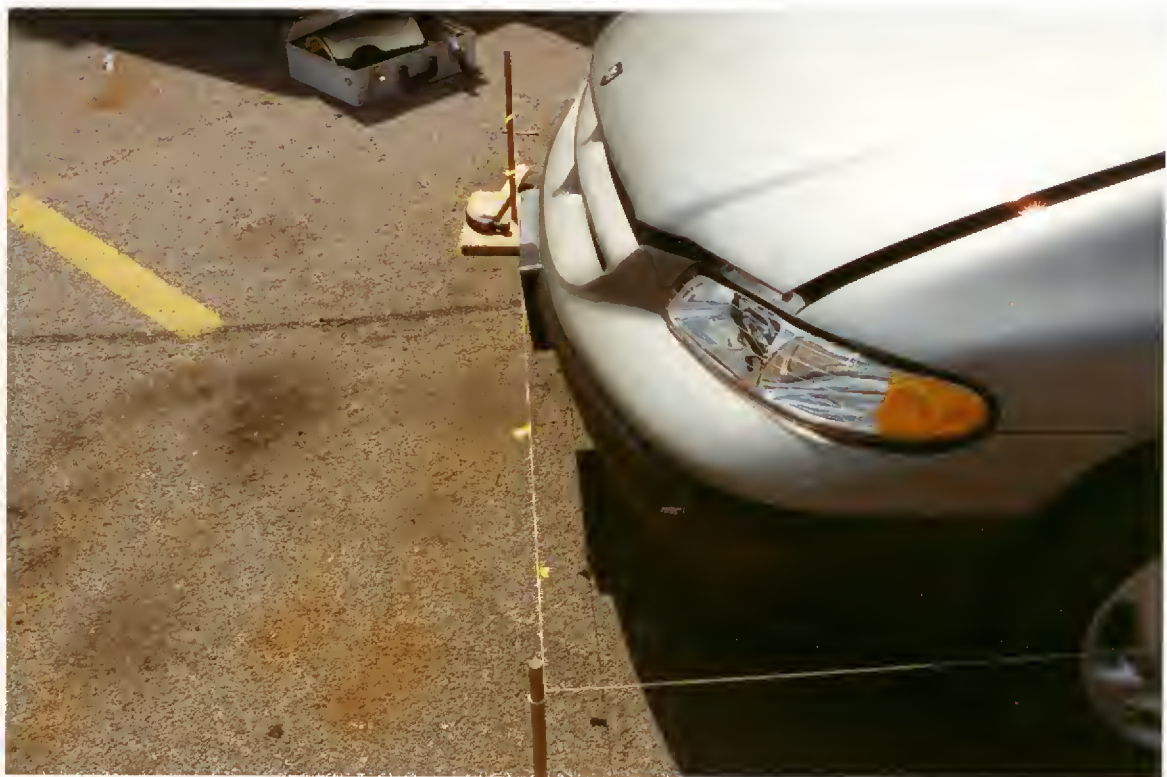
31. Left lateral view of the frontal crush to the Dodge Caravan.

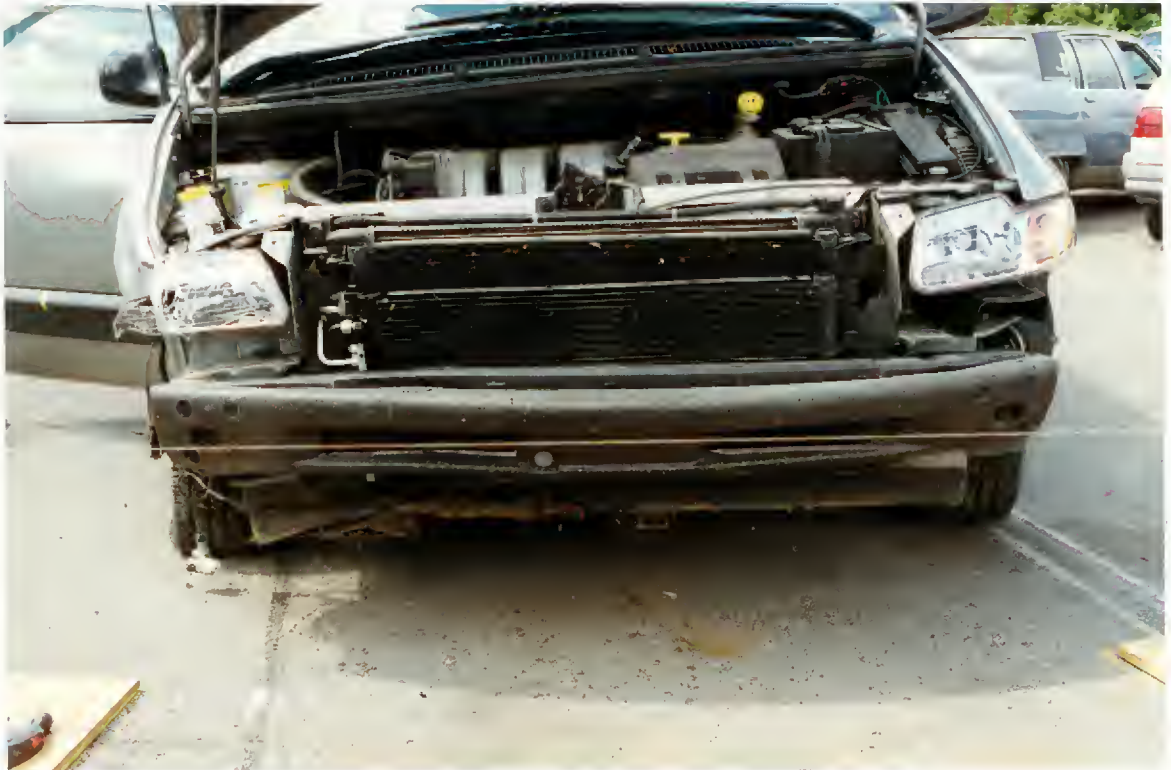
32. Front view of the Dodge Caravan with the bumper fascia removed.

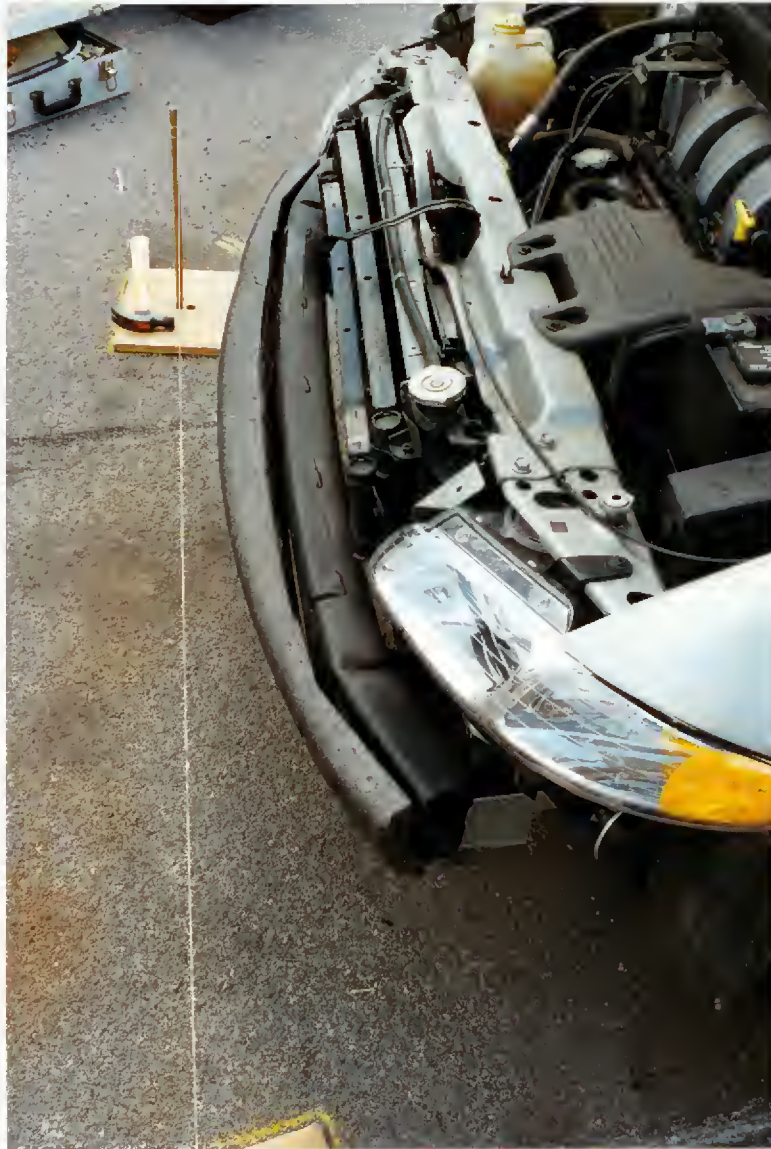
33. Lateral view of the Dodge Caravan bumper reinforcement bar.

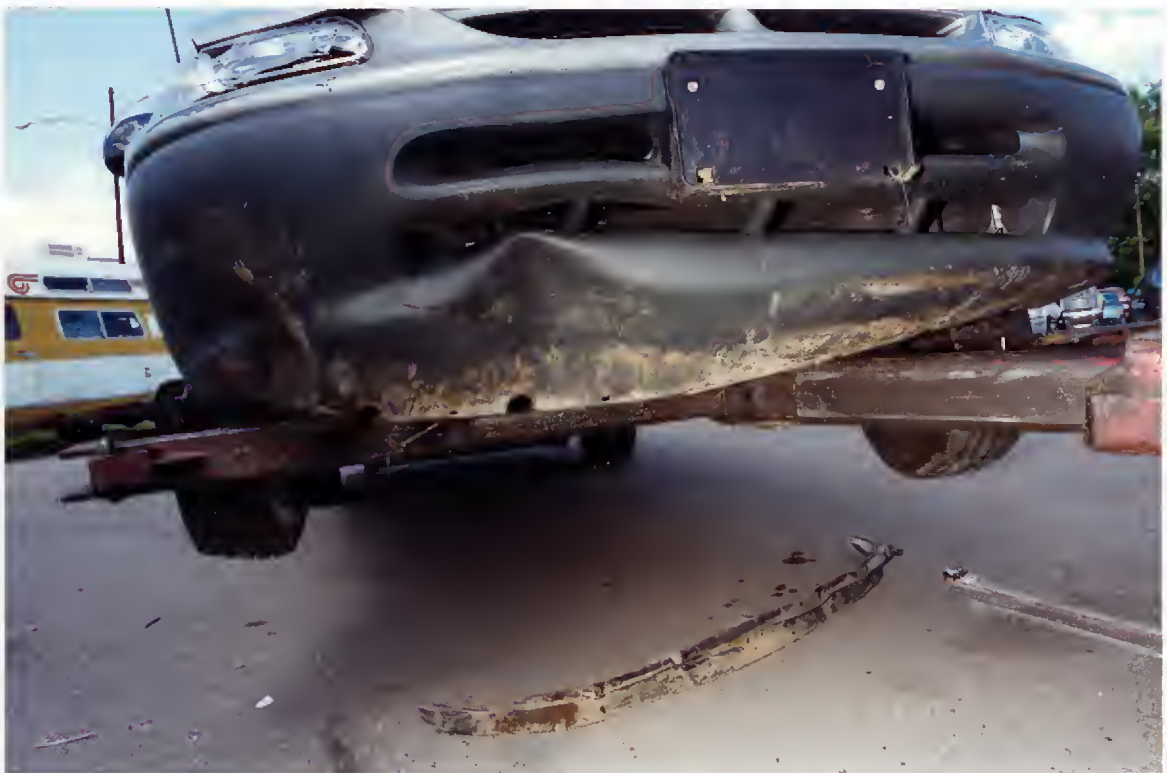
35. Ground view of the right corner of the front bumper fascia.

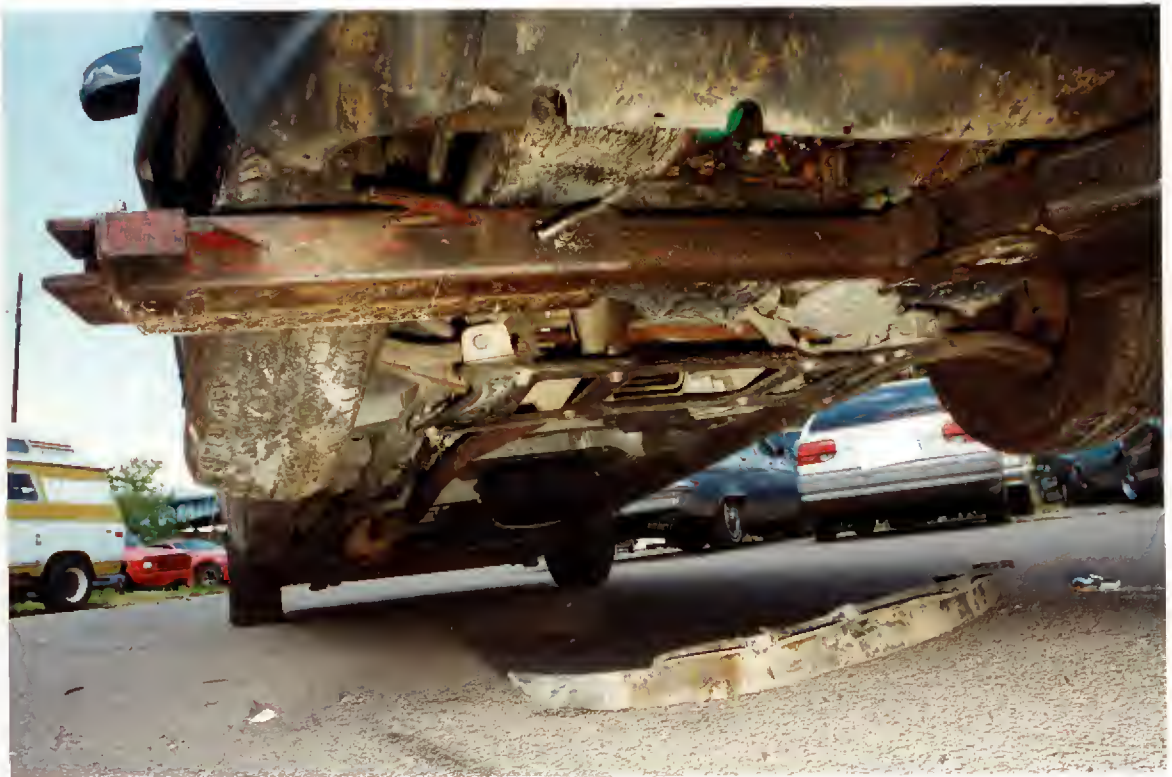
37. View of the forward undercarriage of the Dodge Caravan.

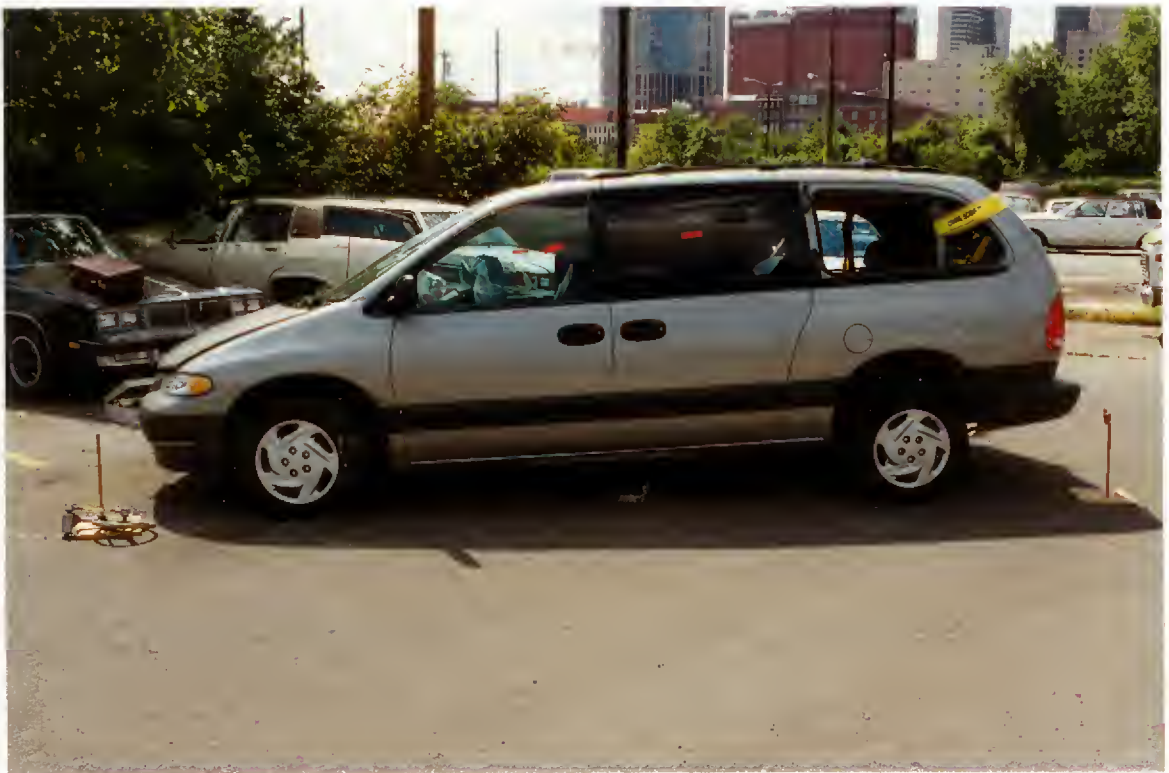
39. Left side view of the Dodge Caravan.

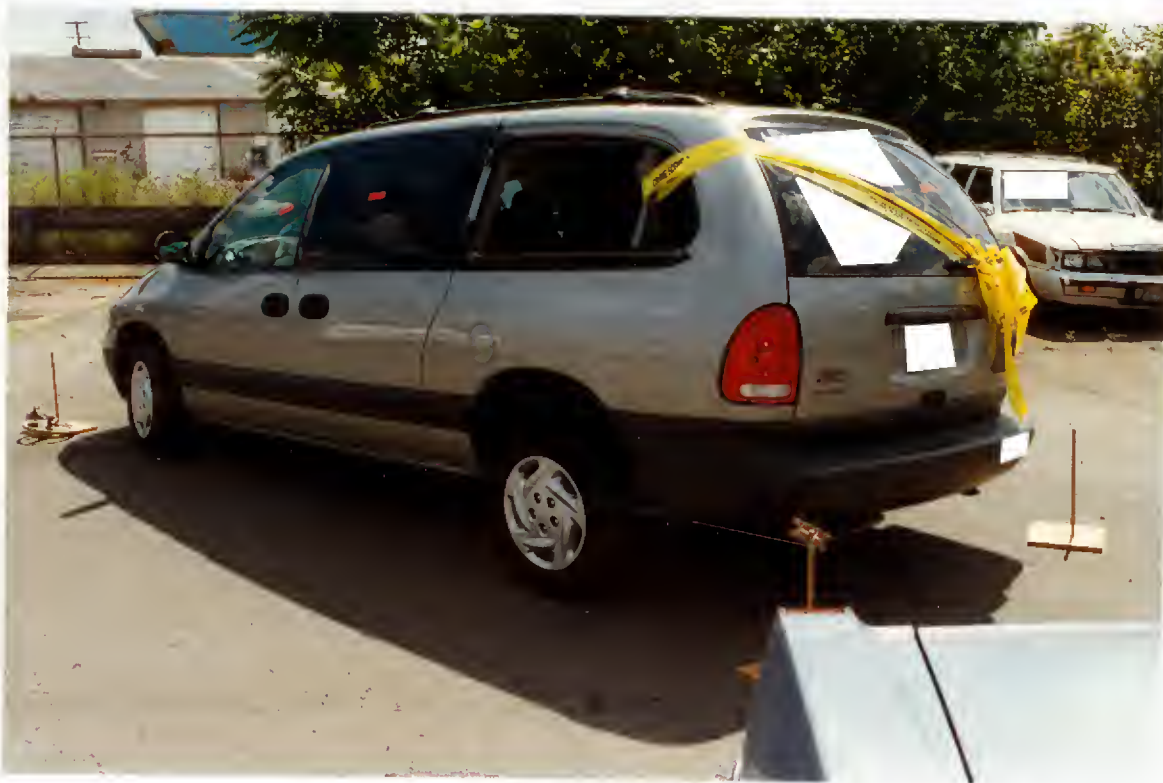
40. Left rear three quarter view.

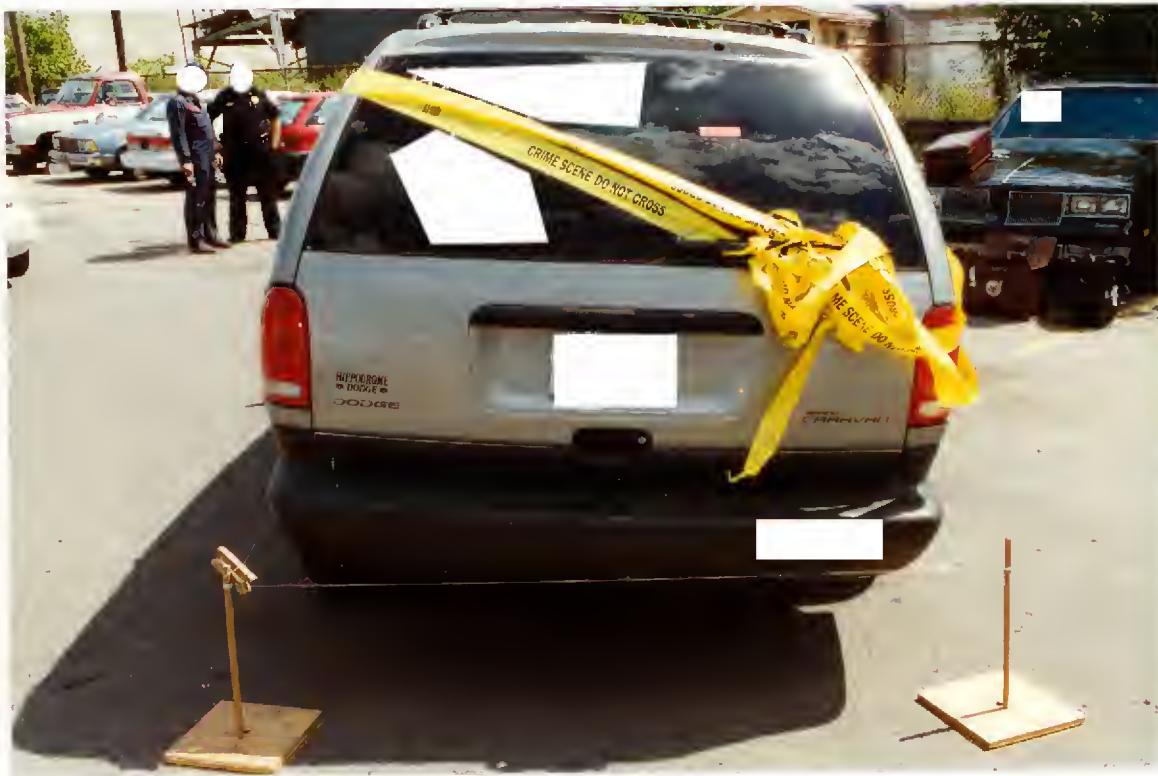
41. Rear view of the Dodge Caravan.

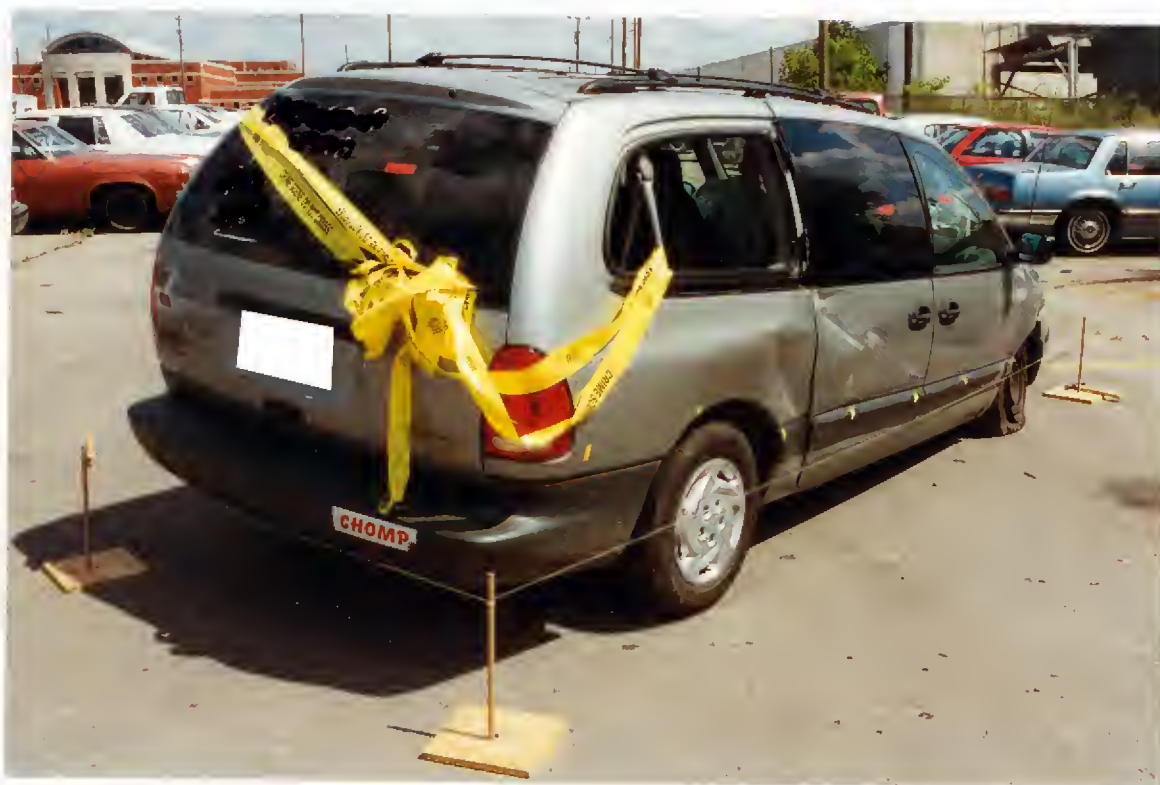
42. Right rear three quarter view.

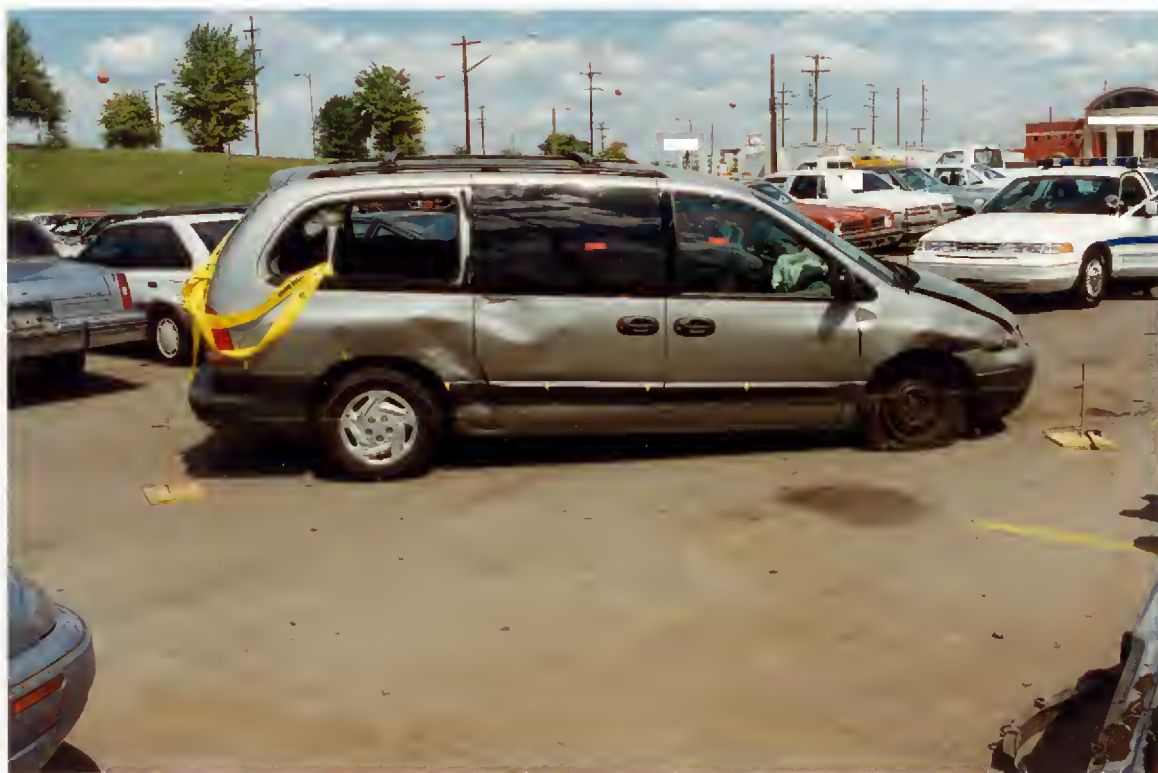
43. Right side view.

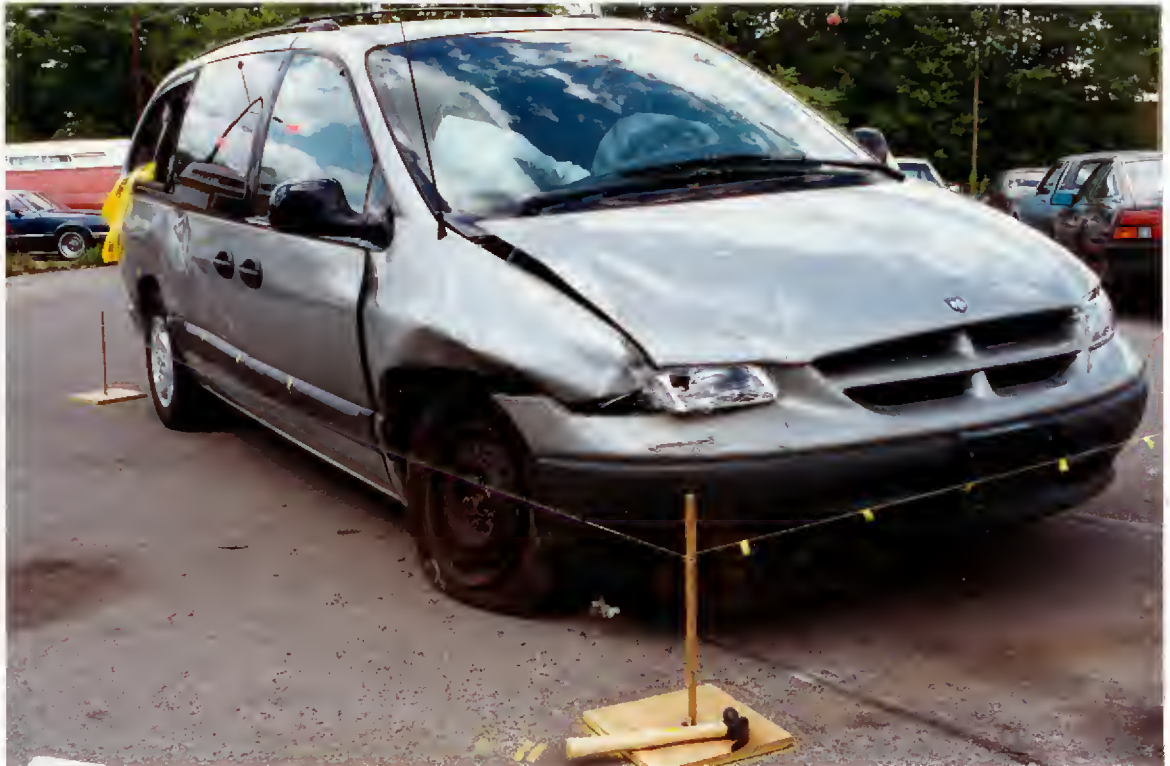
46. Right front three quarter view.

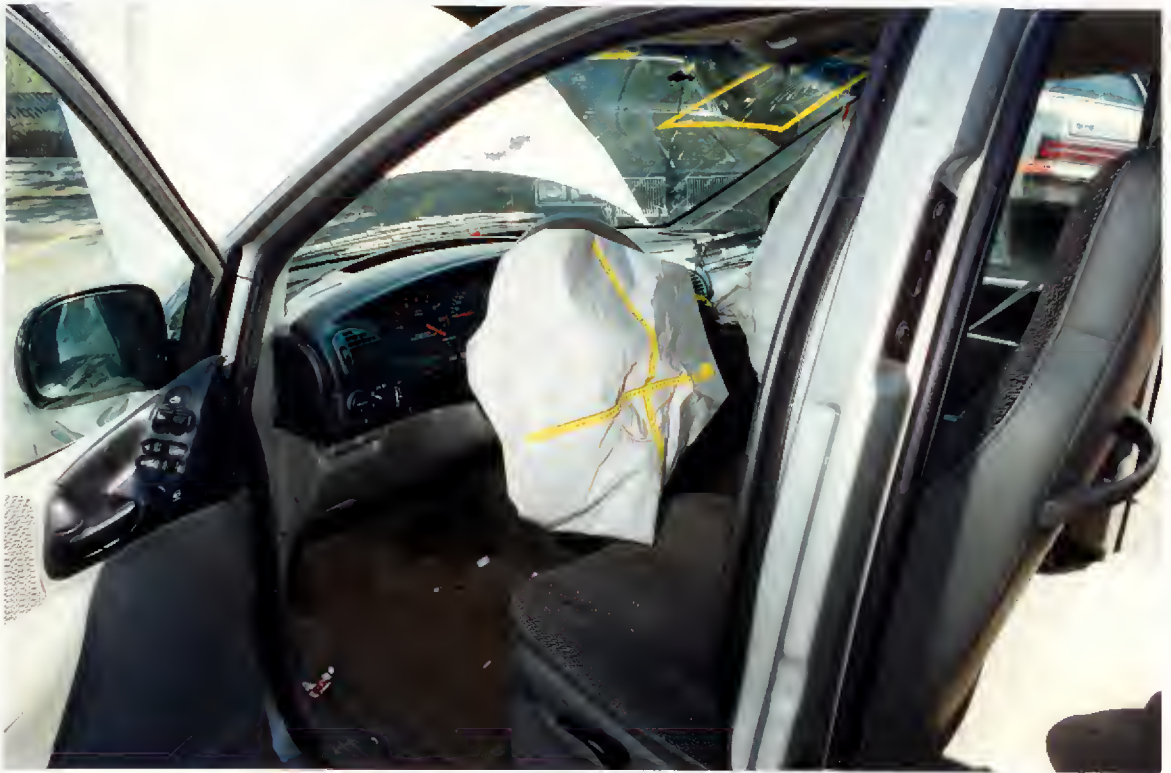
49. Angular view of the driver's compartment.

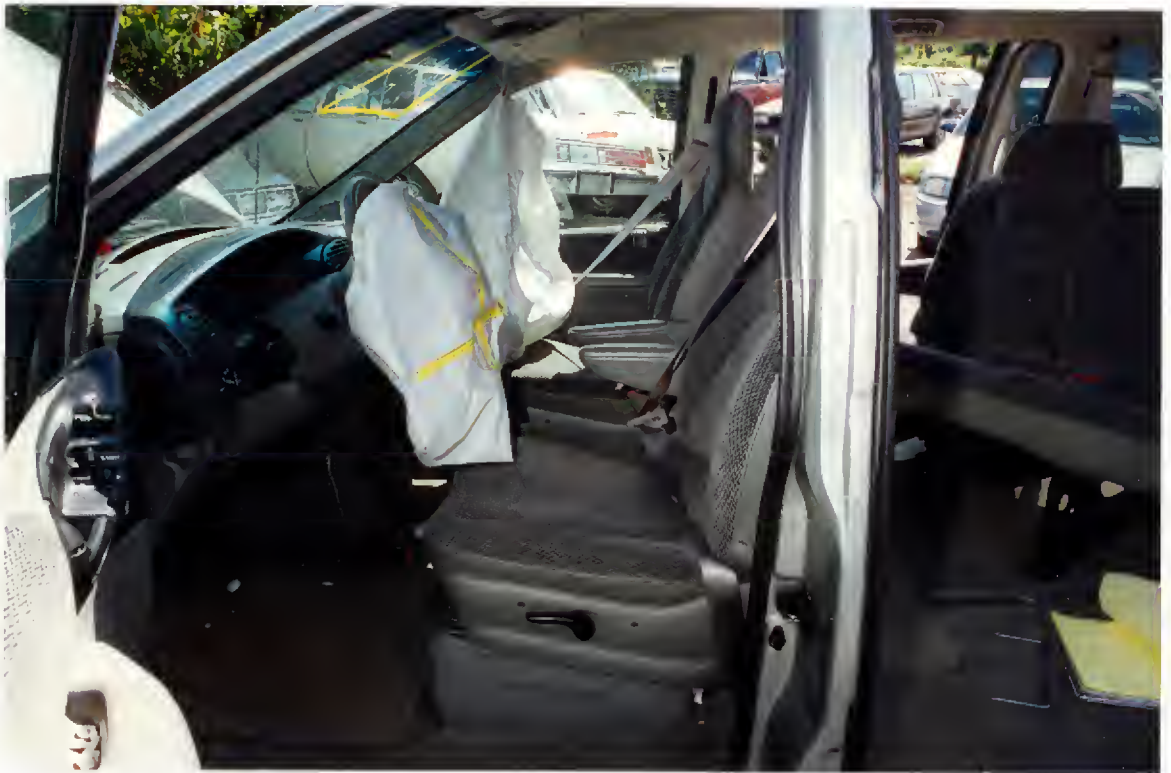
50. Left side view of the front occupant space.

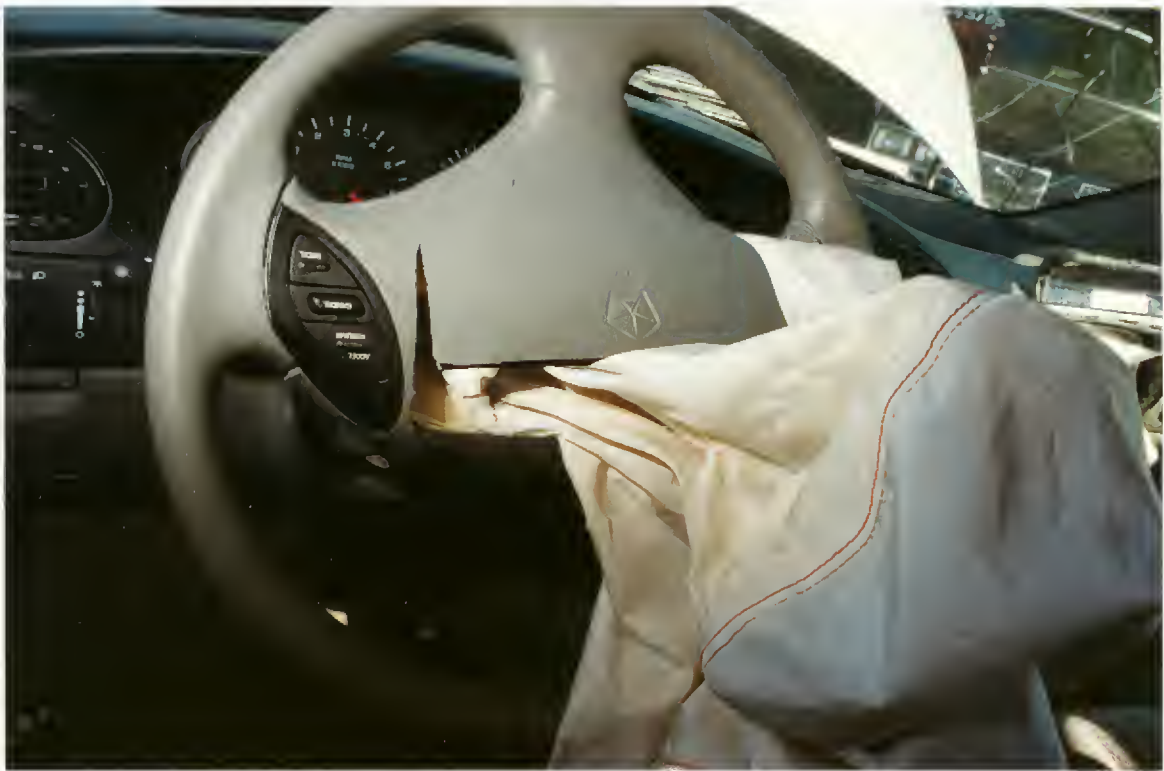
51. View of the steering wheel and the lower module cover flap. Note, the steering wheel is rotated 180 degrees.

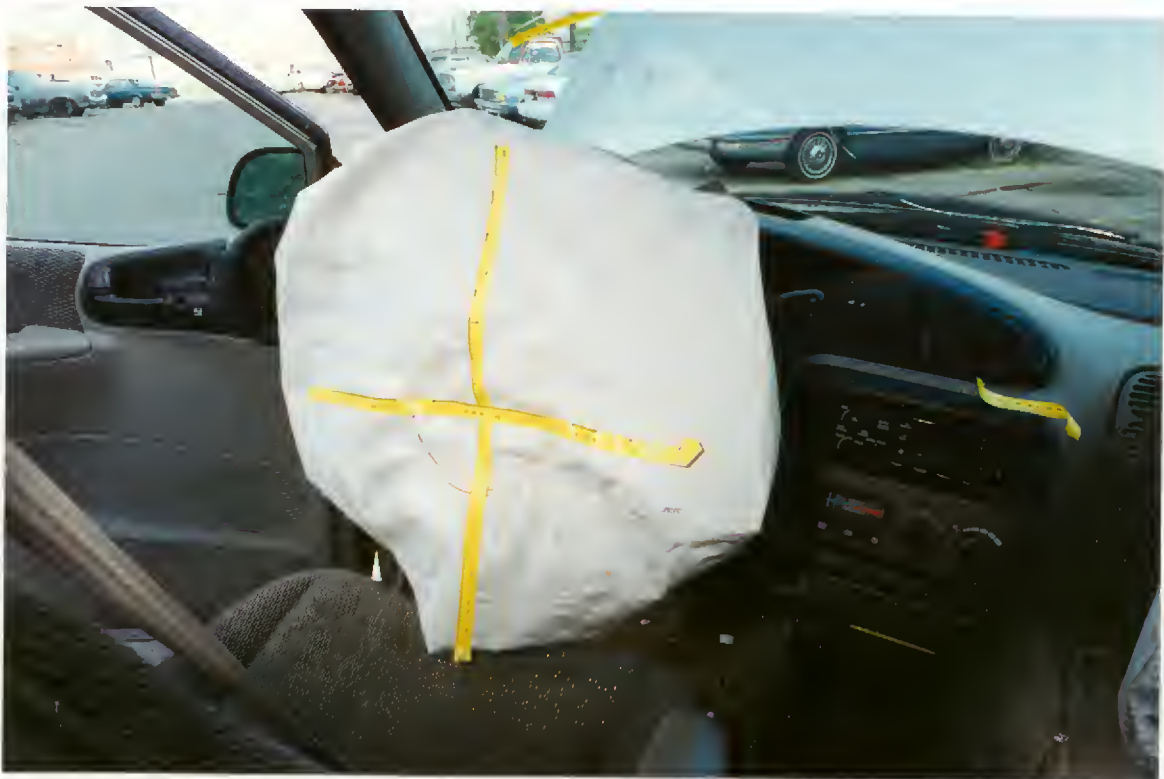
52. Overall view of the deployed driver side air bag.

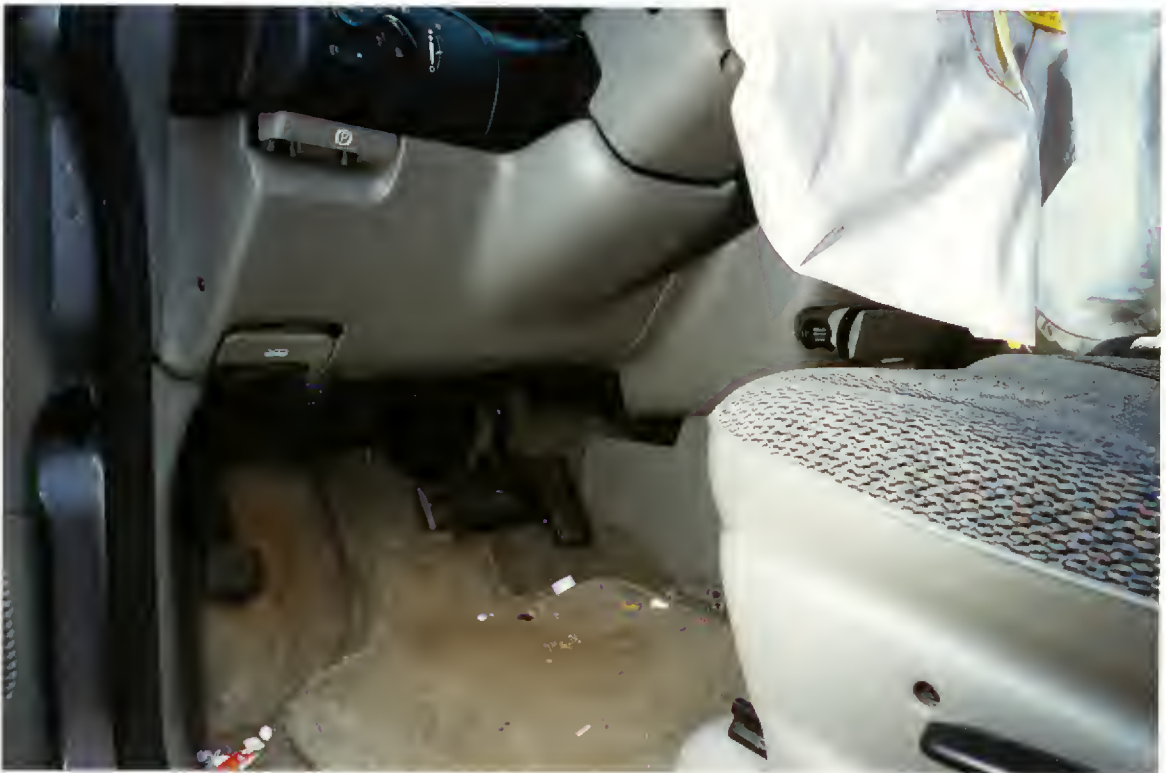
54. View of the driver side knee bolster.

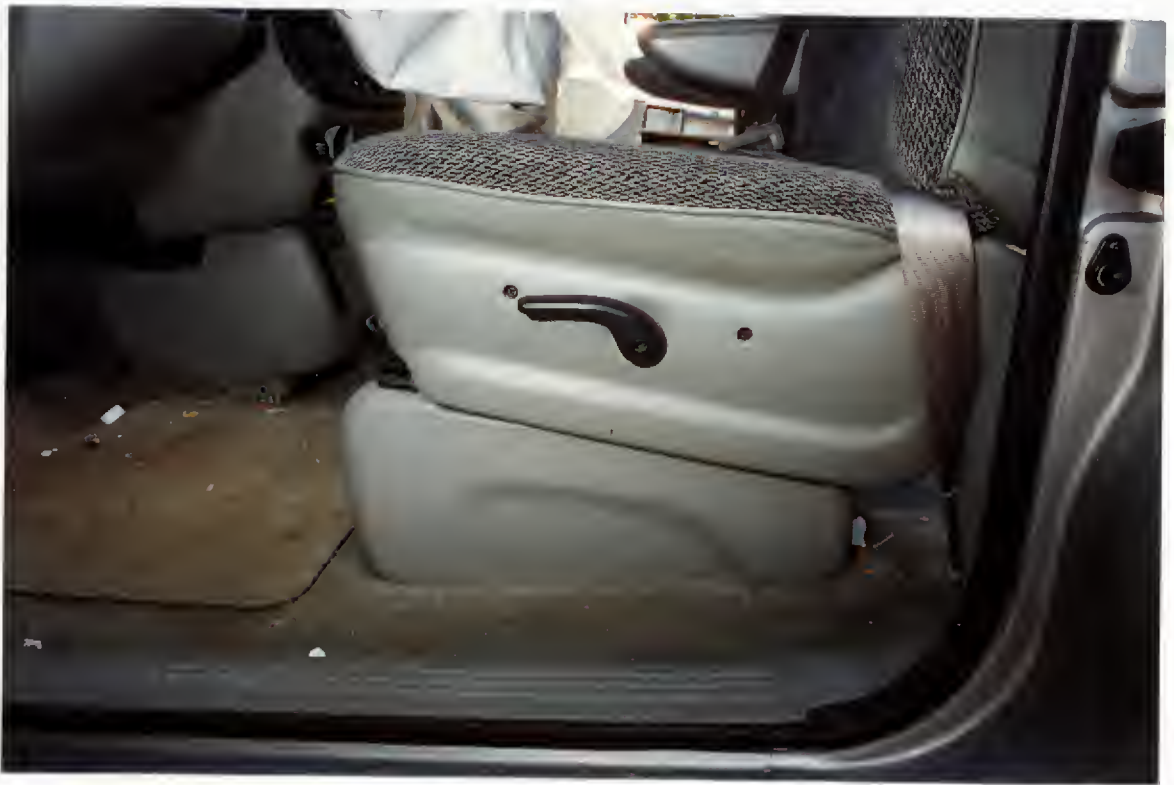
55. View of the driver seat track position.

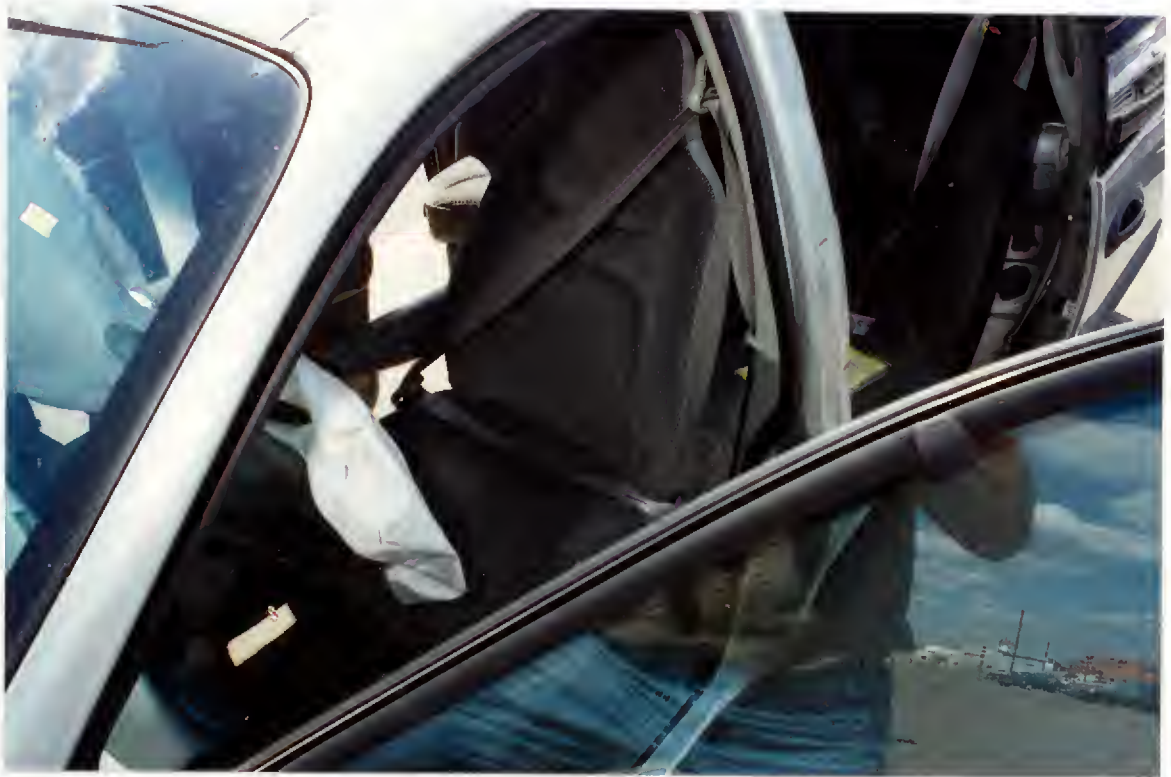
56. Overall view of the driver seat and restraint.

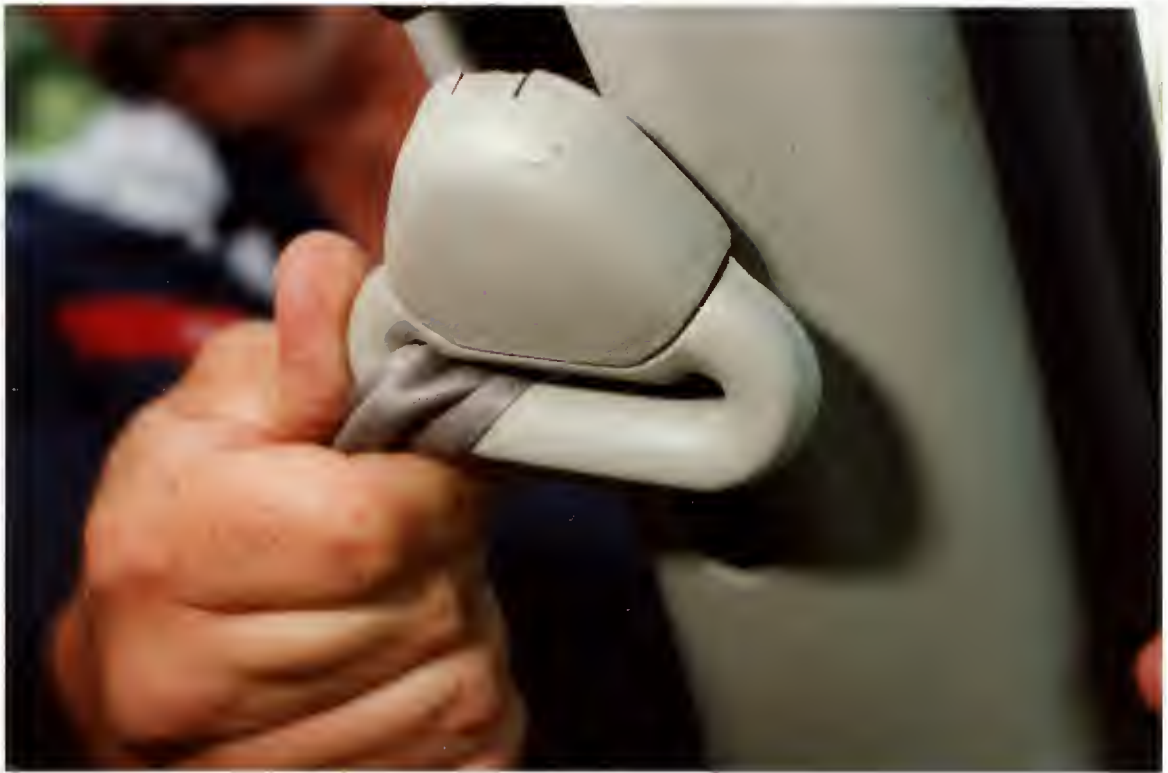
57. Close-up view of the left front D-ring.

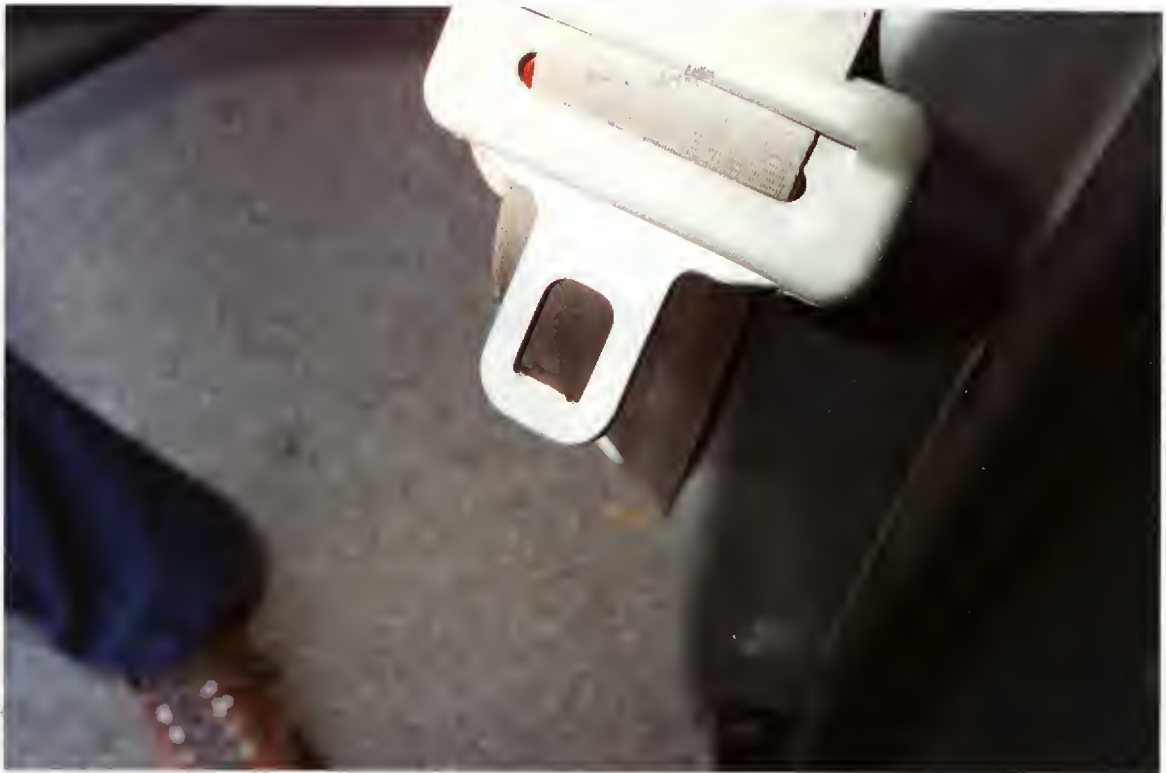
58. View of the left front seat belt's latch plate.

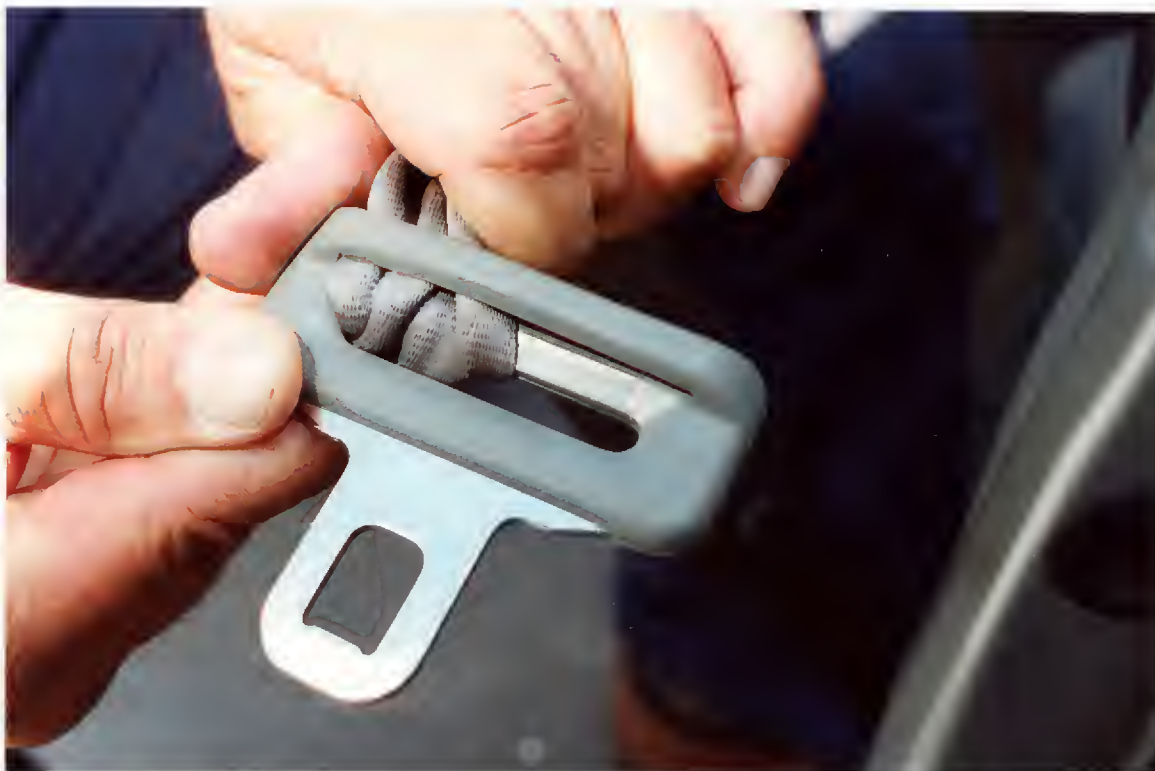
The 1996 Dodge Caravan was equipped with manual 3-point lap and shoulder belts in the six outboard seated positions. The front seat belt systems consisted of a continuous loop lap and shoulder belt webbings with locking latchplates. Emergency locking retractors were mounted in the base of each B-pillar. The belt systems utilized an adjustable upper anchorage (D-ring). The driver's D-ring was found adjusted to a point that was 2.0 cm (0.8 in) below the full up position, or 7.6 cm (3.0 in) above the bottom adjustment point, yielding a total of 9.6 cm (3.8 in) of vertical adjustment. The driver was wearing the manual 3-point shoulder belt. Routine usage marks present on the latchplate. There was no loading evidence on the driver's seat belt webbing, however, the latchplate crossbar exhibited a 1.3 cm (0.5 in) abrasion to the polymer coating at the forward aspect of the crossbar (refer to Photograph No. 59).

59. View of an abraded area on the plastic covering the latch plate.

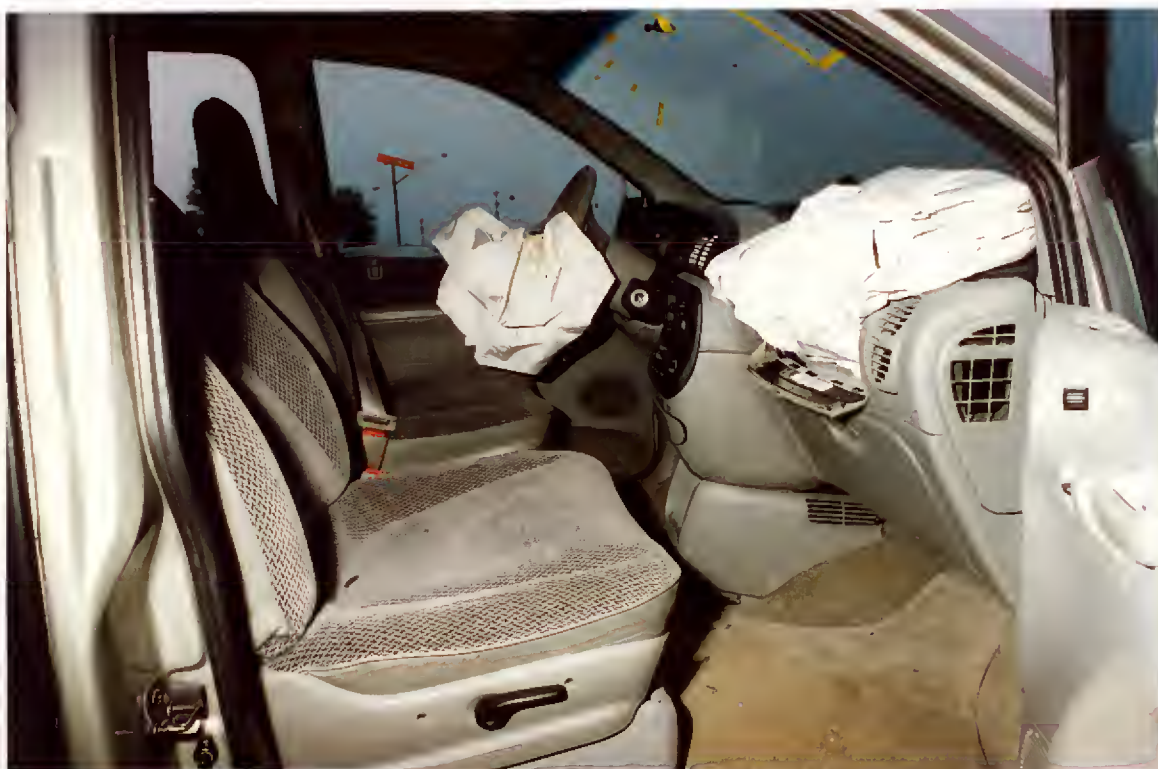
60. Right side view of the forward occupant compartment.

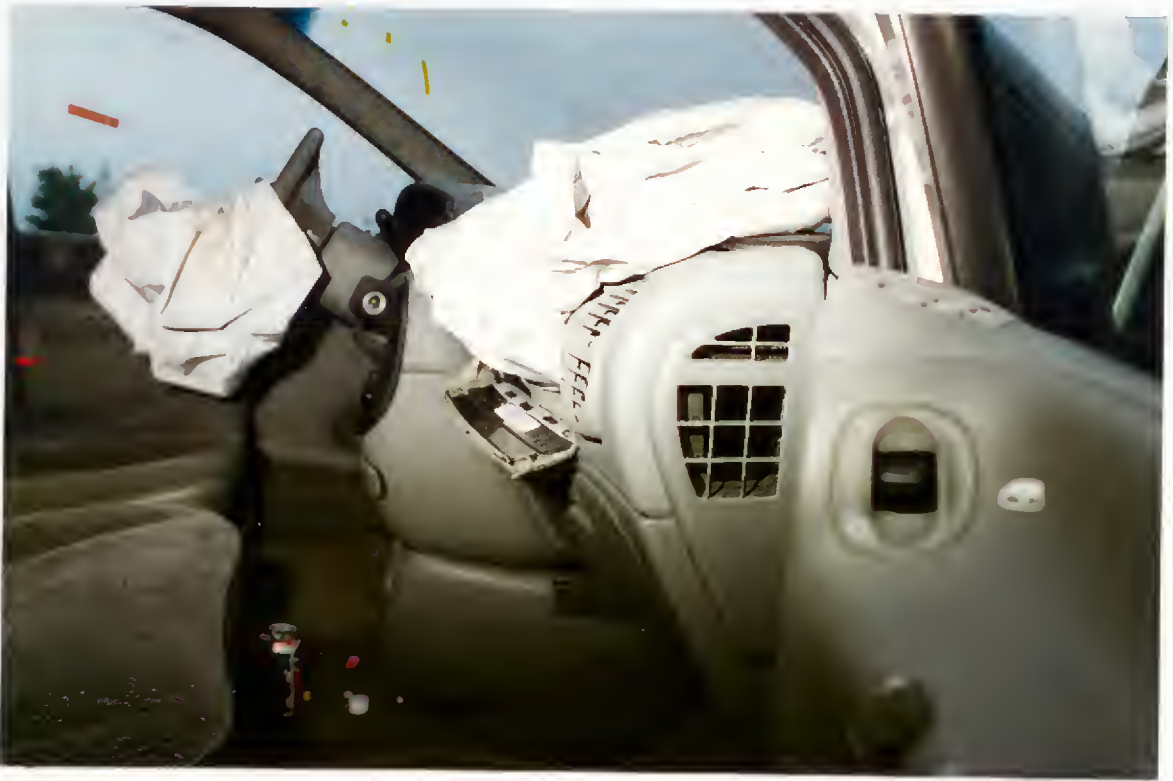
61. Right perpendicular view of the instrument panel.

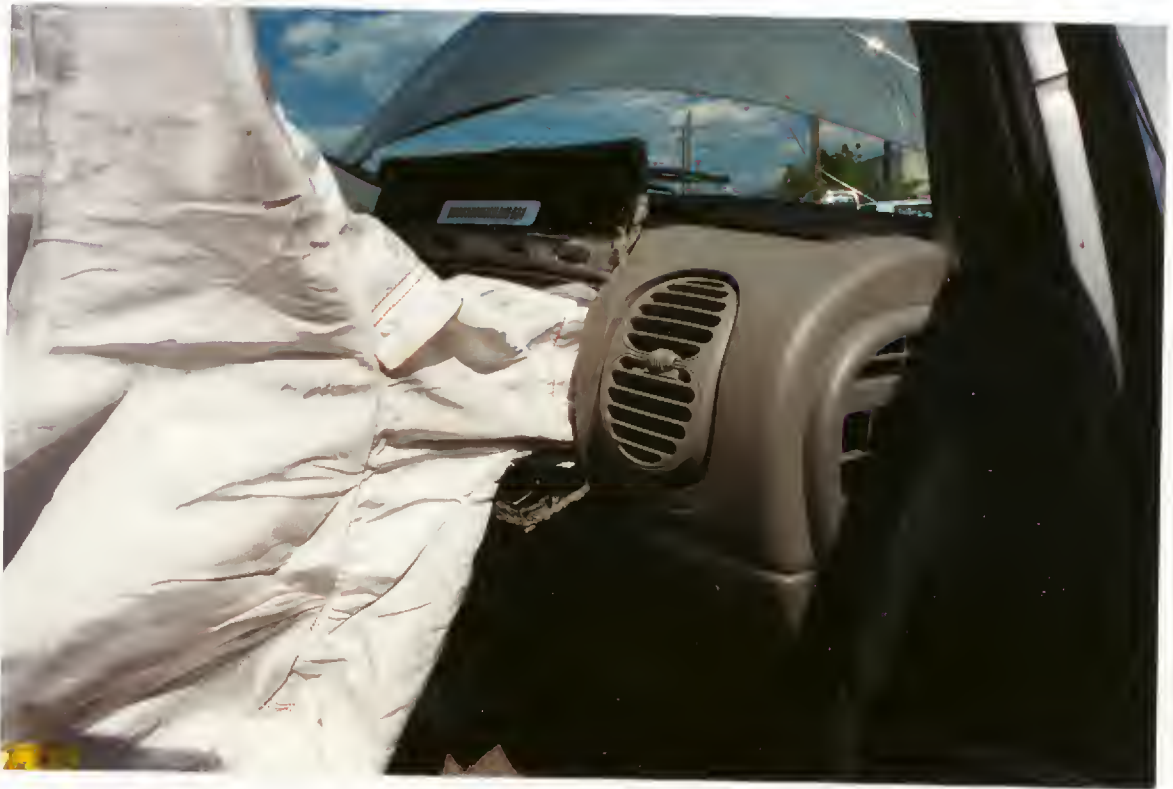
62. Overall view of the mid-mount passenger side air bag module.

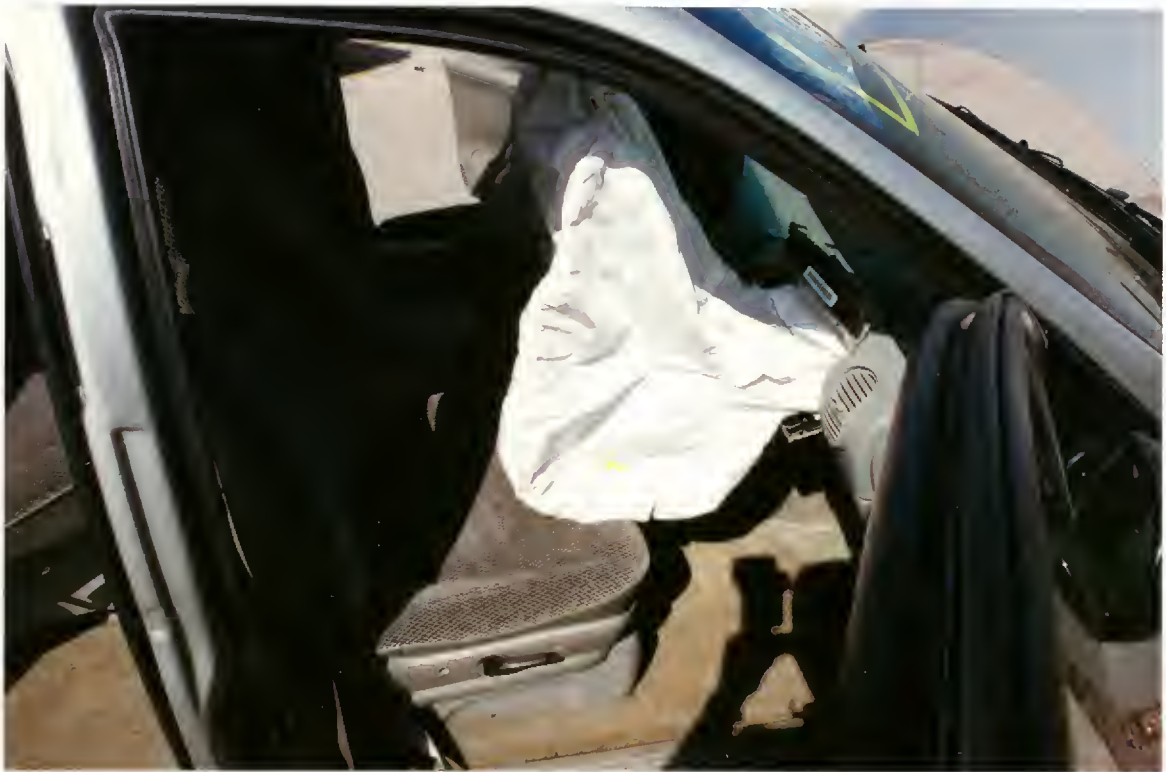
63. Overall right side view of the air bag in simulated deployment.
